CONSTRUCTION PROCESS

Rowner Research Project Phase One

March 2014

This is the third factsheet in the series, covering the construction process of the project.

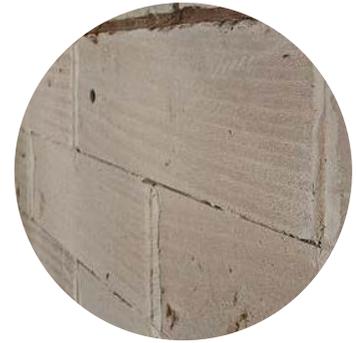
Thin-Joint block-work

- For the use of Thin-Joint blockwork, coursing blocks were not used to achieve the required sill, lintel and floor heights.
- The construction team reported that the material of the blocks did not allow for the helical ties to be hammered in through easily and a hole was required to be drilled for the ties. An alternate approach was used on site and the ties fixed within the mortar joints as the blockwork was being laid. It is however not clear whether this was a problem with the product (which was from a mainstream manufacturer), a requirement for specialist skills, or lack of familiarity with the new system and the procurement.

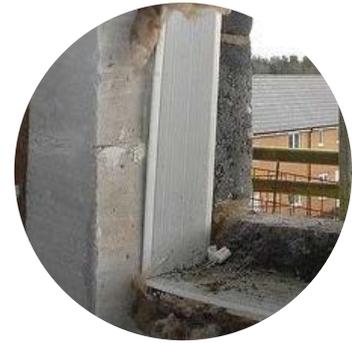
Window opening construction

- There were instances where it appeared that the cavity closers around window openings were formed by mineral wool. While this may be due to the proximity of the window to the fire stops between dwellings, this would limit the uniformity with which the blown bead insulation would fill the cavity.

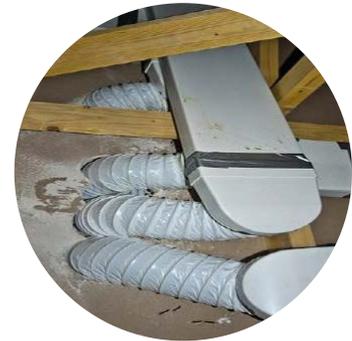
MVHR ductwork

- The use of flexible ductwork should have been limited in the MVHR installation. Some sharp bends and angles were observed that could have affected the MVHR system's performance.

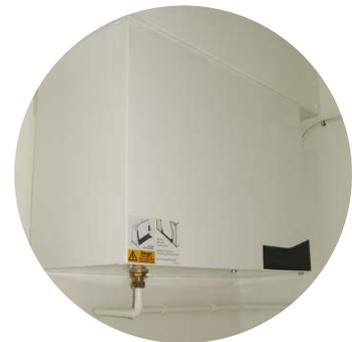
Boxed MVHR unit

- In order to ensure airtightness of the building fabric, the ductwork coming in and out of the MVHR unit was boxed over. However, there wasn't enough consideration for access to the control panel for maintenance and this boxing was subsequently removed.
