- Two identical block of flats – 12 flats each (mirrored floor plan layouts)
- Two different energy efficiency targets (CSH L3, FEES)
- No renewable energy generation systems installed
- Modern Method of Construction (Thin-Joint Masonry)
- Mechanical Ventilation Heat Recovery (MVHR) in all flats

Introduction to the project

Phase II – Post Occupancy evaluation

Phase III – The Overheating Study

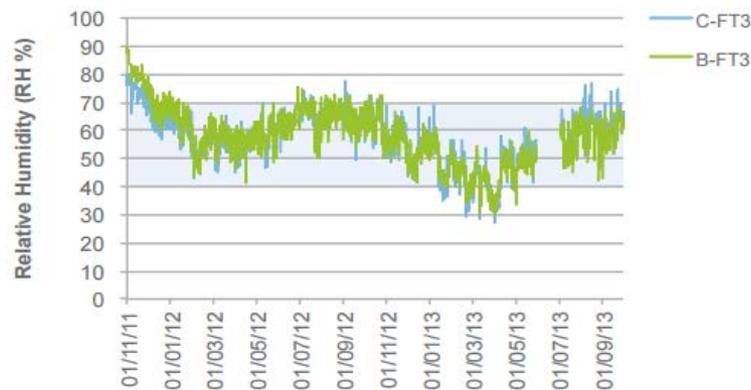
The humidity levels in both sub-metered flats were within the acceptable range for most of the project's duration.
