TESTING PROGRAMME

Rowner Research Project Phase One

March 2014

Testing at Rowner research project

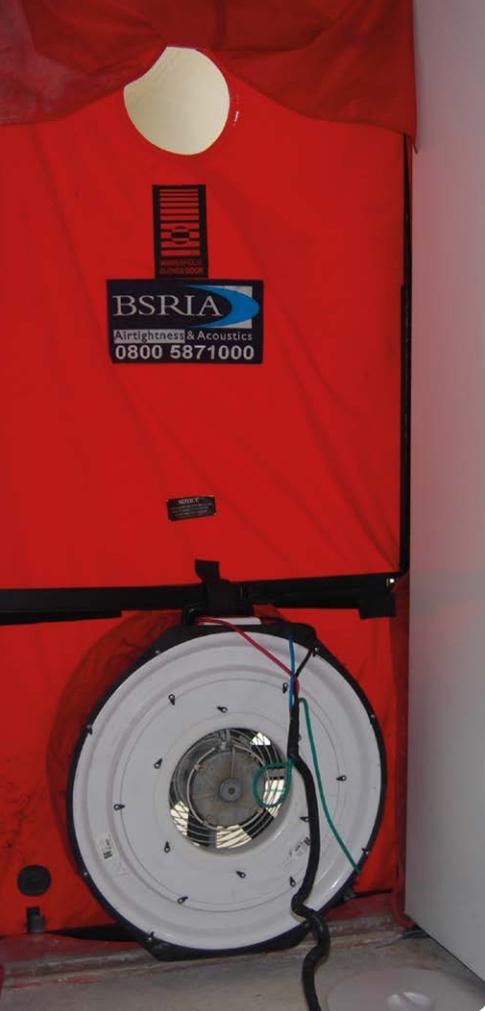
Blower door test equipment

Air pressure testing - Blower door test

In Rowner air leakage tests were conducted on a ground floor, mid floor and top floor flat in both blocks.

In addition to the testing that took place to comply with Building Regulations, a set of air pressure tests was carried out on sample flats in the two blocks to understand how different stages of construction contribute towards achieving a target air permeability rate in buildings. These tests were performed at 3 stages:

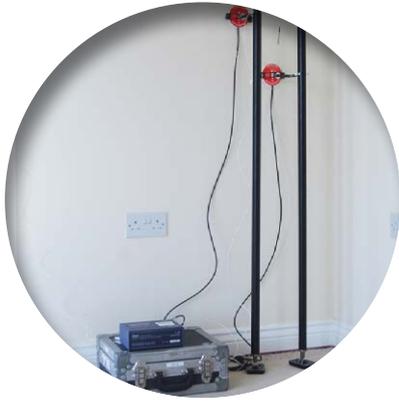
Heat flux sensors

U-values were measured in situ using heat flux sensors during the co-heating test. These sensors measured the rate of heat transfer through the walls, an indication of the actual rate of heat loss. The values calculated were higher than the design values but within expected deviation.
