CONSTRUCTION PROCESS

Rowner Research Project Phase One

March 2014

This is the third factsheet in the series, covering the construction process of the project.

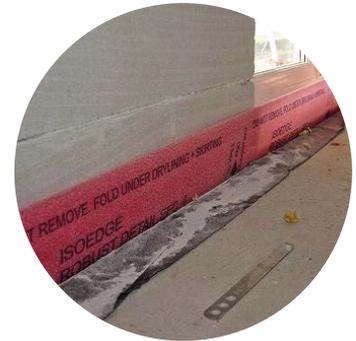
Sound insulation along floor edge

A concrete beam and Expanded Polystyrene (EPS) insulation block suspended floor system was used for both blocks, with a sound isolating membrane incorporated along the DPC. Intermediate floors were constructed using concrete planks.

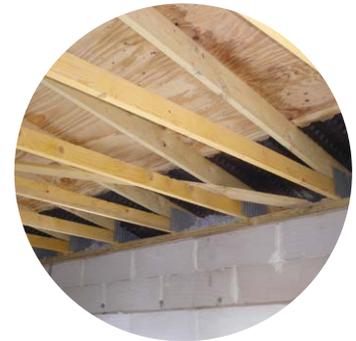
Roof space

The roof was insulated along the ceiling line with mineral wool between and over the joists to achieve a U-value of 0.10W/m²K. The ventilated roof space was used to run the mechanical ventilation ductwork for the top floor flats.
